Manhole Inspection Summary

Manhole # S25AA1020MH

Location Address: **3566 POOLE ST**

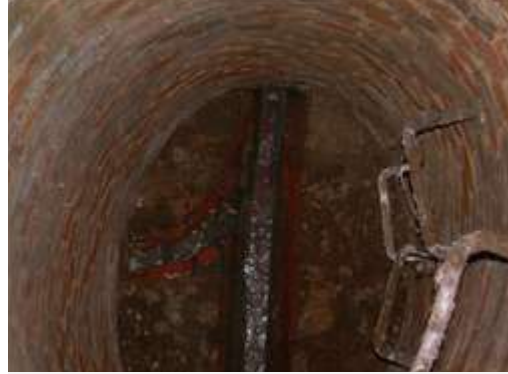
Top View

Corroded steps. Bench debris.

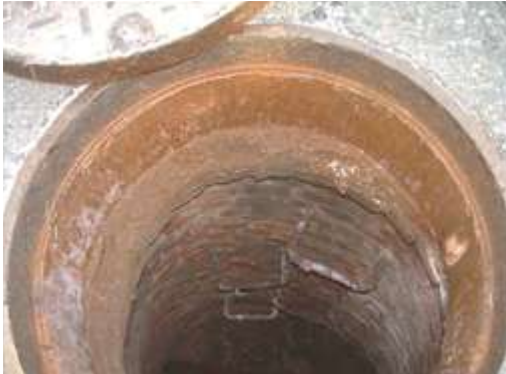
Defect

Frame leaks. Frame offset. Corroded steps. Adjustment deterioration and infiltration. Corbel infiltration.

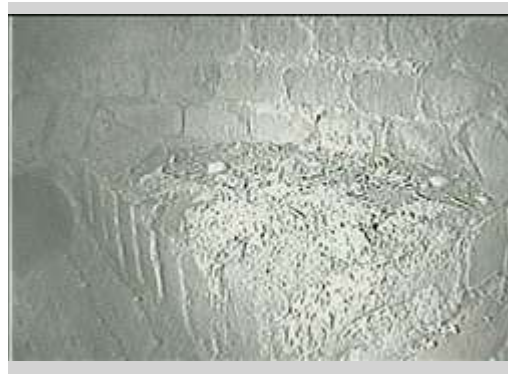
Defect

Barrel deterioration and infiltration. Bench debris.

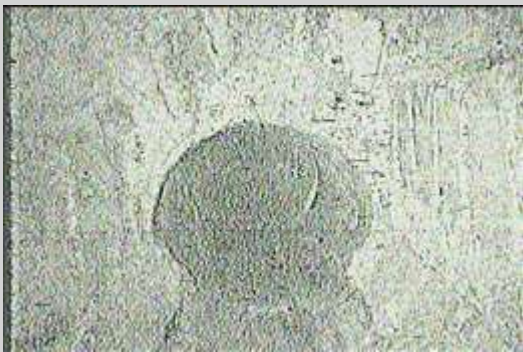
8 in. Circular Gravity Sewer Pipe Out @ 12 O'Clock

Invert Depth: **9.12** (ft.) Flow Characteristics: **Slow**

Infiltration: **None** Pipe Seal Cond: **Unknown**

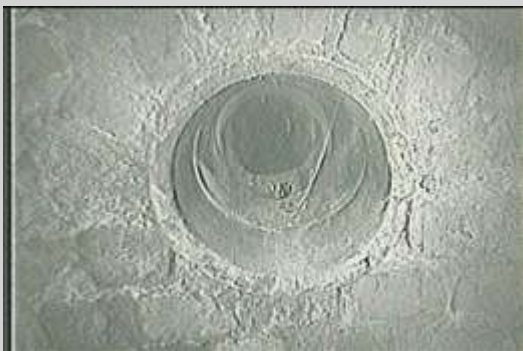
8 in. Circular Gravity Sewer Pipe In @ 6 O'Clock

Invert Depth: **7.30** (ft.) Flow Characteristics: **Slow**

Infiltration: **None** Pipe Seal Cond: **Unknown**

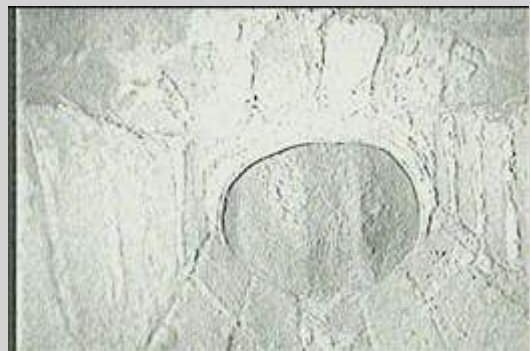
Drop In @ 6 O'Clock

Drop: **Outside** Rod and Bar

Drop Condition: **Open**

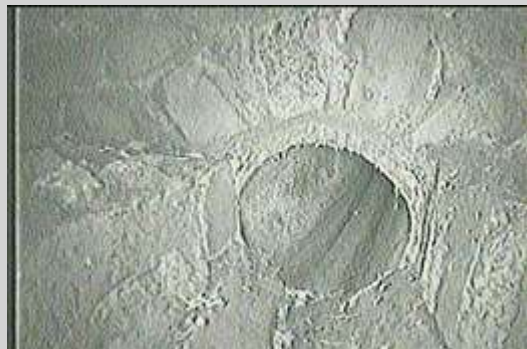
Pipe In @ 9 O'Clock

Invert Depth: **8.77** (ft.) Flow Characteristics: **None**

Infiltration: **None**
